Ohio River Mainstem Systems Study (ORMSS)

Interim Feasibility Report: J.T. Myers and Greenup Locks Improvements

Document GE:

General Engineering Reference Data

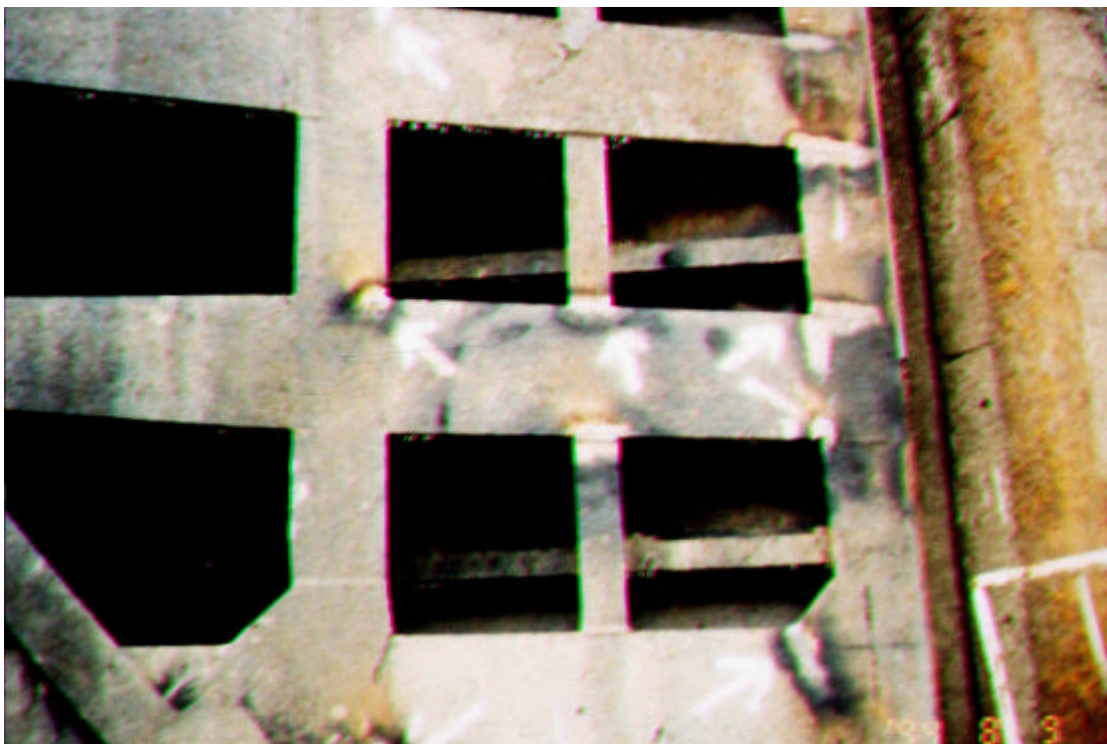
Figure 6.2.2.A Main Chamber Miter Gate Cracking Above Pintle

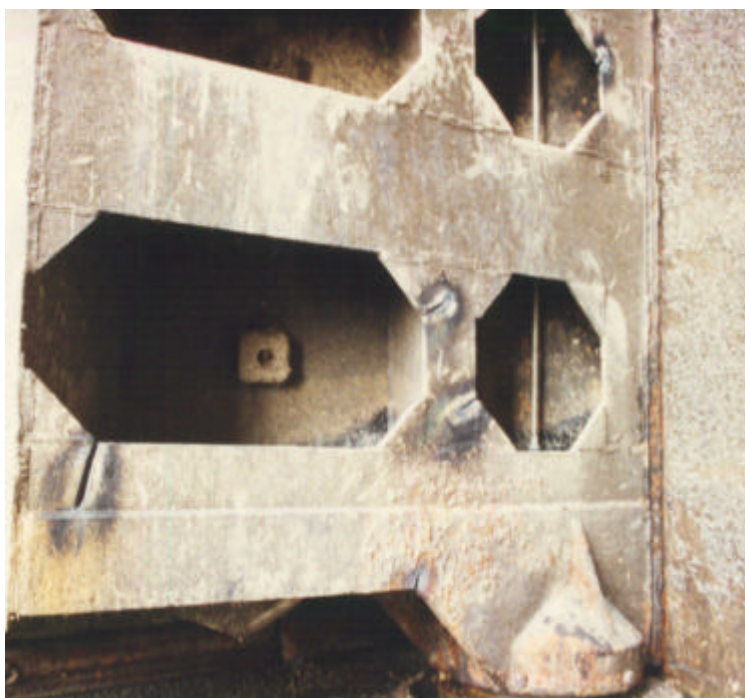
Figure 6.2.2.B Main Chamber Miter Gate Crack Repair in Pintle Region

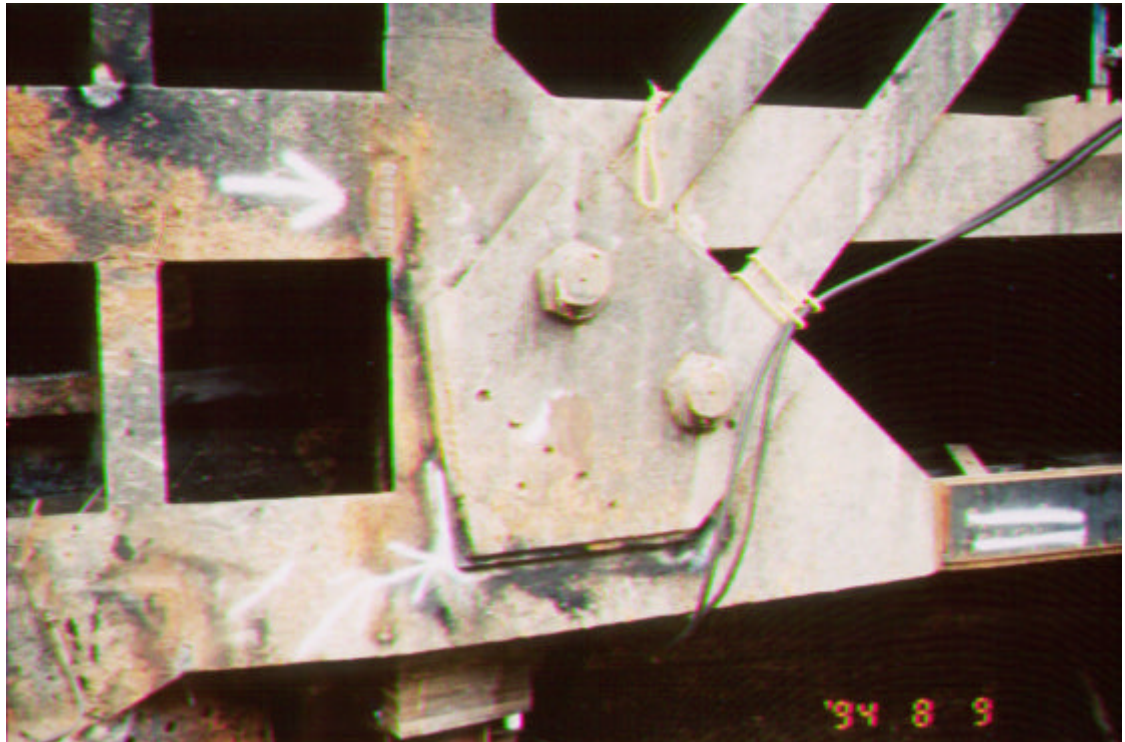
Figure 6.2.2.C Main Chamber Miter Gate Cracking Near Diagonal Plate

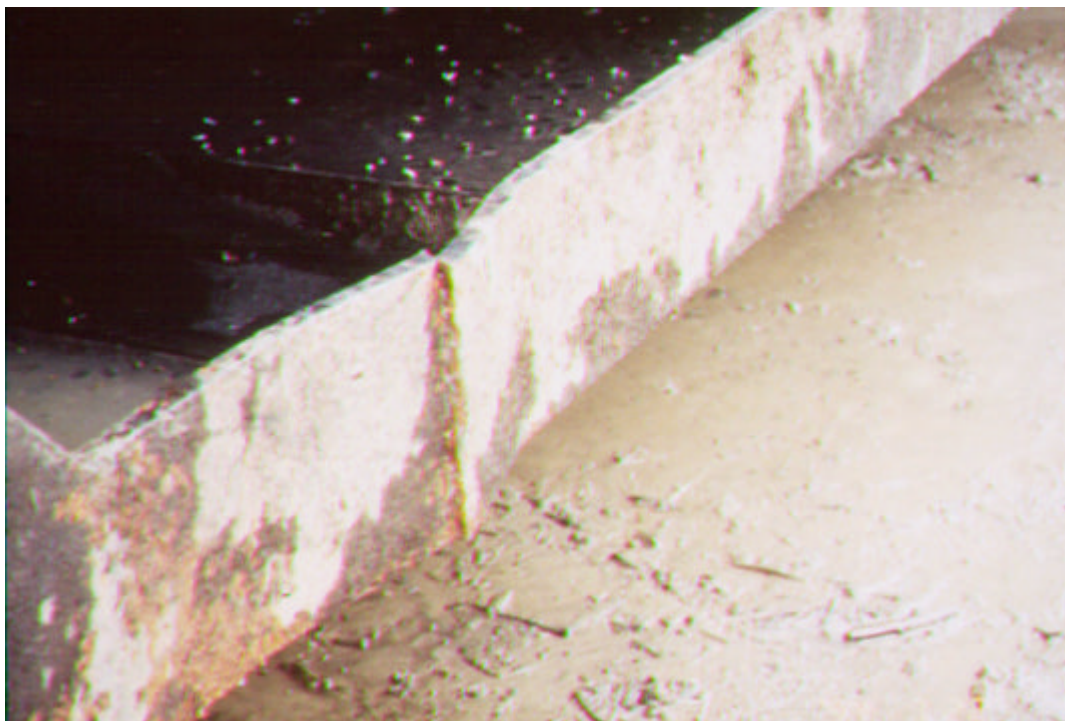
Figure 6.2.2.D Miter Gate Damage to Lower Girder Downstream Flange

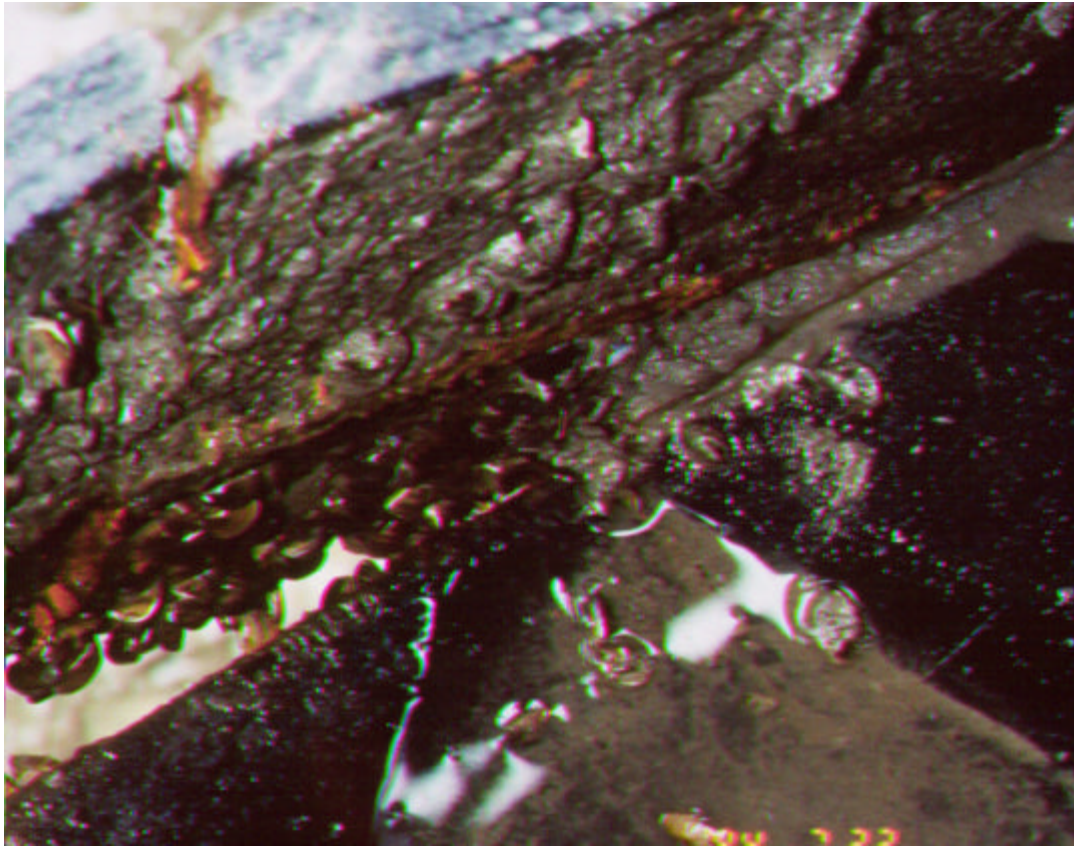
Figure 6.2.2.E is a photograph that shows a close-up of the damage to the flange plate looking from "inside" the girder towards the downstream flange plate. Note the separation of the flange plate from the web of the girder.

Figure 6.2.2.E Miter Gate Damage to Lower Girder Downstream Flange

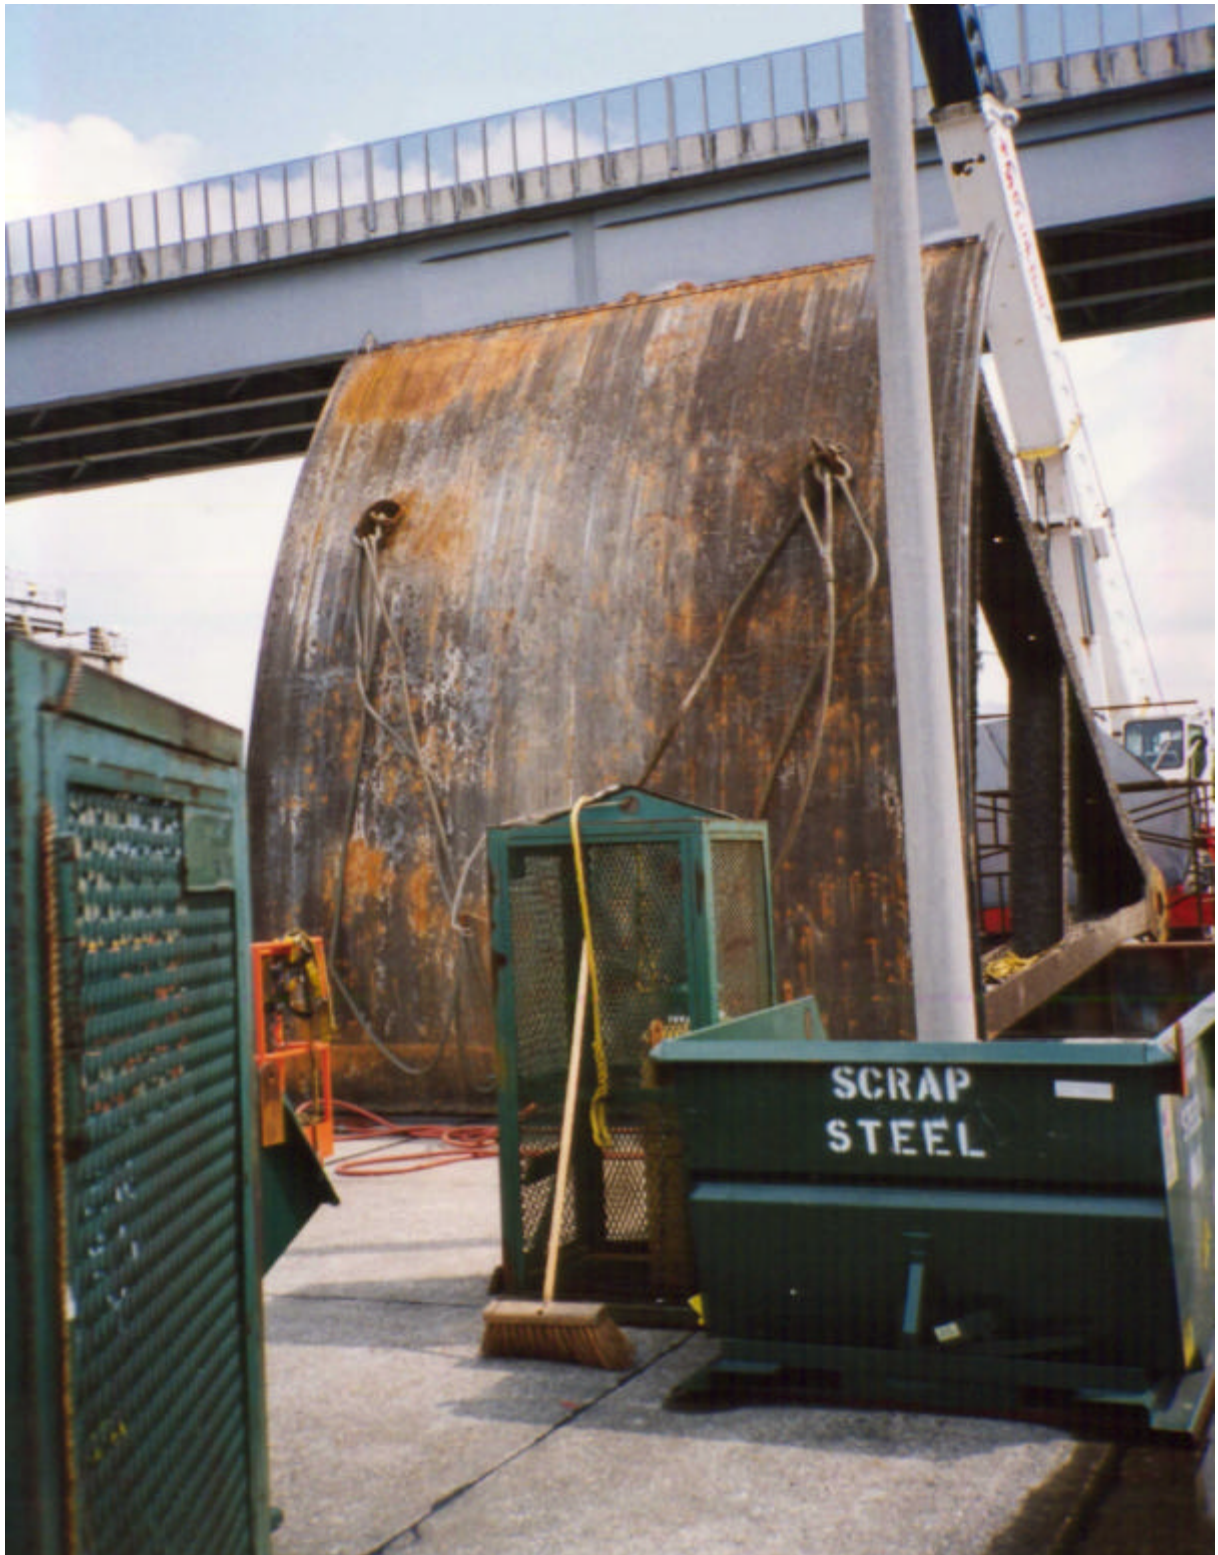
Figure 6.4.2.B. Front View of Markland Reverse Tainter Culvert Valve.
Note surface deterioration of skin plate

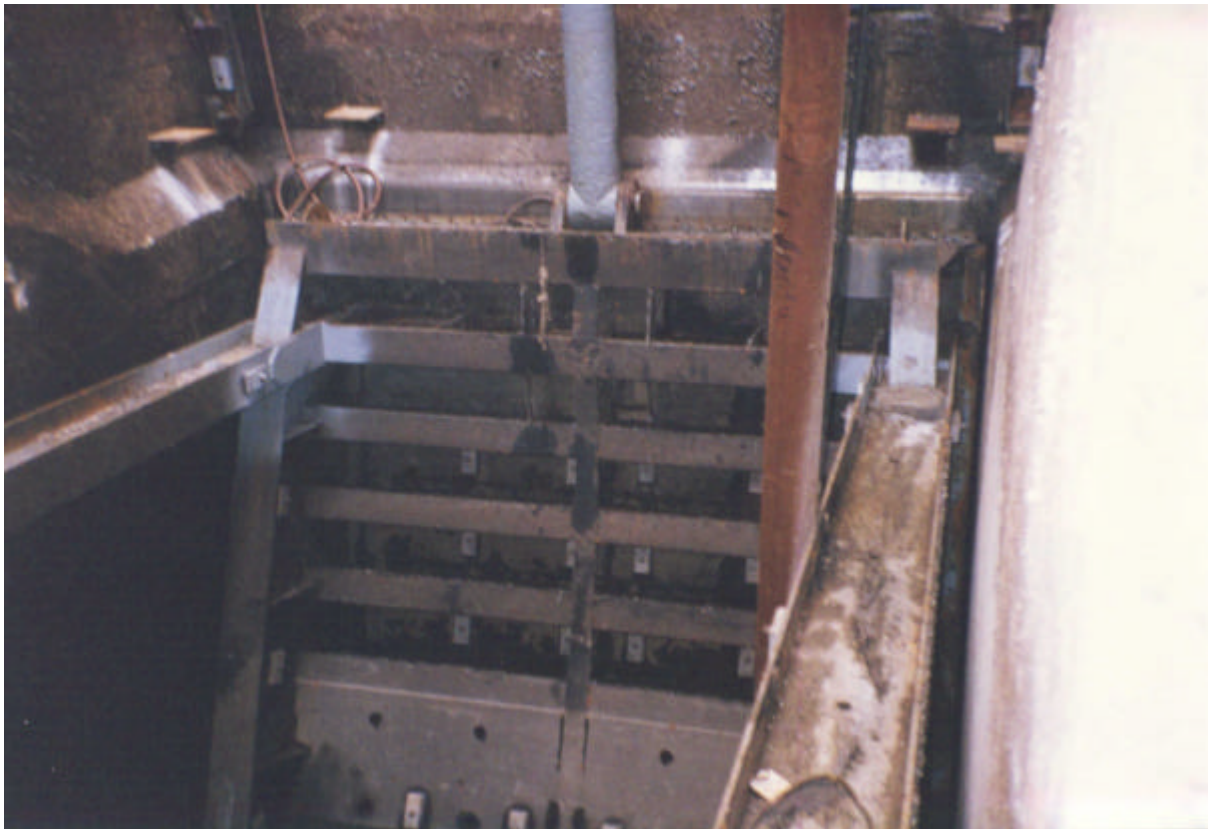
Figure 6.4.2.C. Markland Culvert Valve in the Pit
Note the corrosion of the valve relevant to the spot -painted areas.

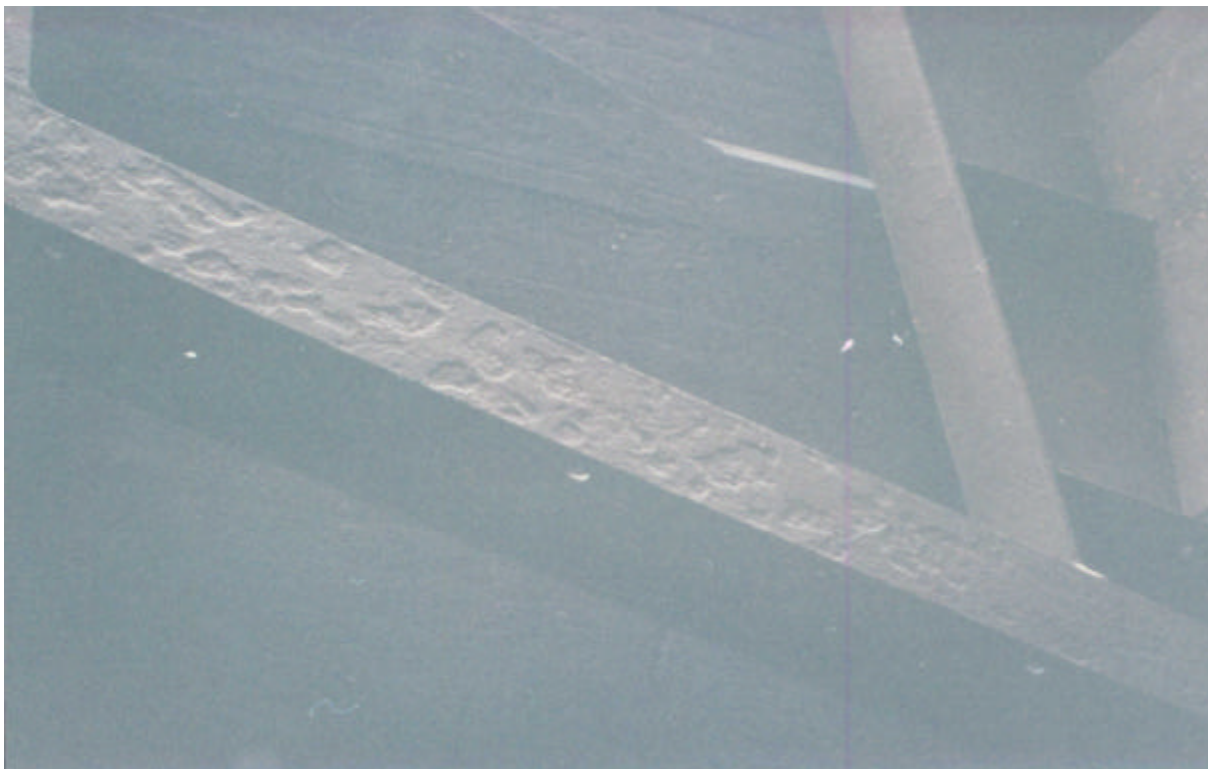
Figure 6.4.2.D. Markland Culvert Valve Strut Arm
Note heavy pitting and corrosion of strut arm.

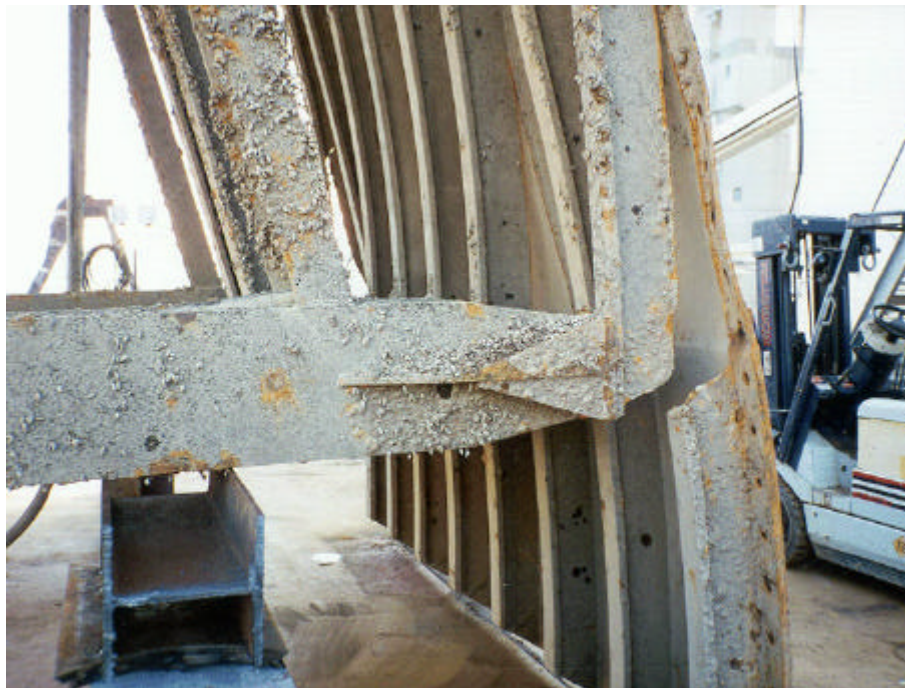
Figure 6.5.2.B. Side View of Failed Smithland Valve

Note sheared rib at strut arm and offset of curved ribs above and below horizontal girder .

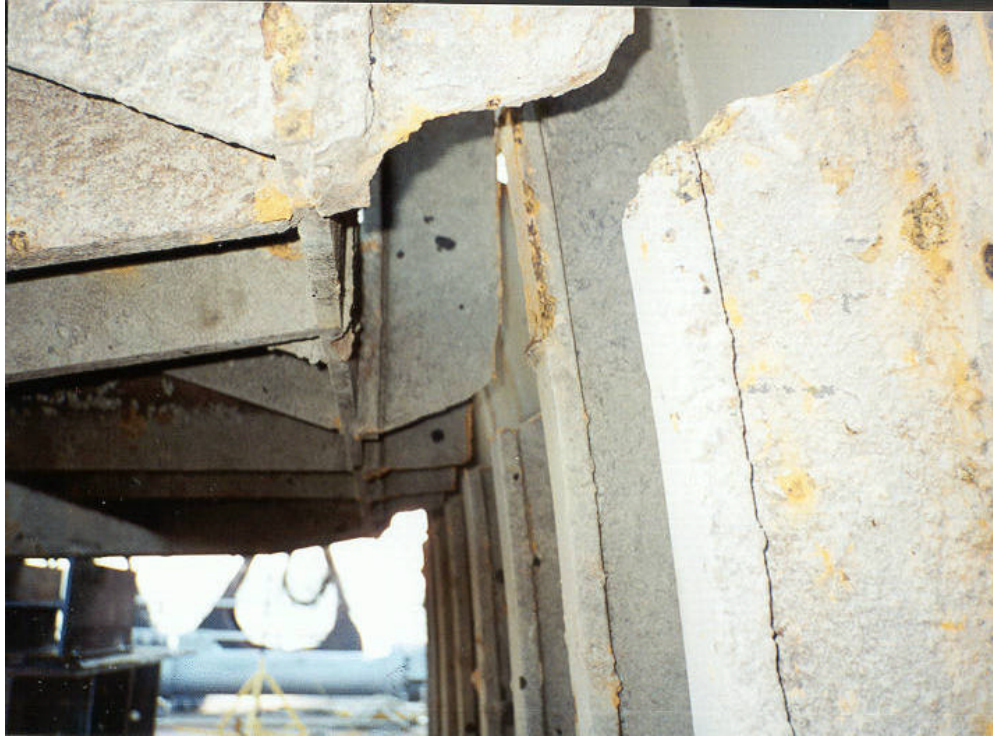
Figure 6.5.2.C. Side View of Failed Curved Ribs at Bottom Horizontal Girder

Note the failure of the weld at horizontal girder in 2nd rib from end. Same weld failure occurred at 2nd rib from other end as well. All other ribs failed in shear.

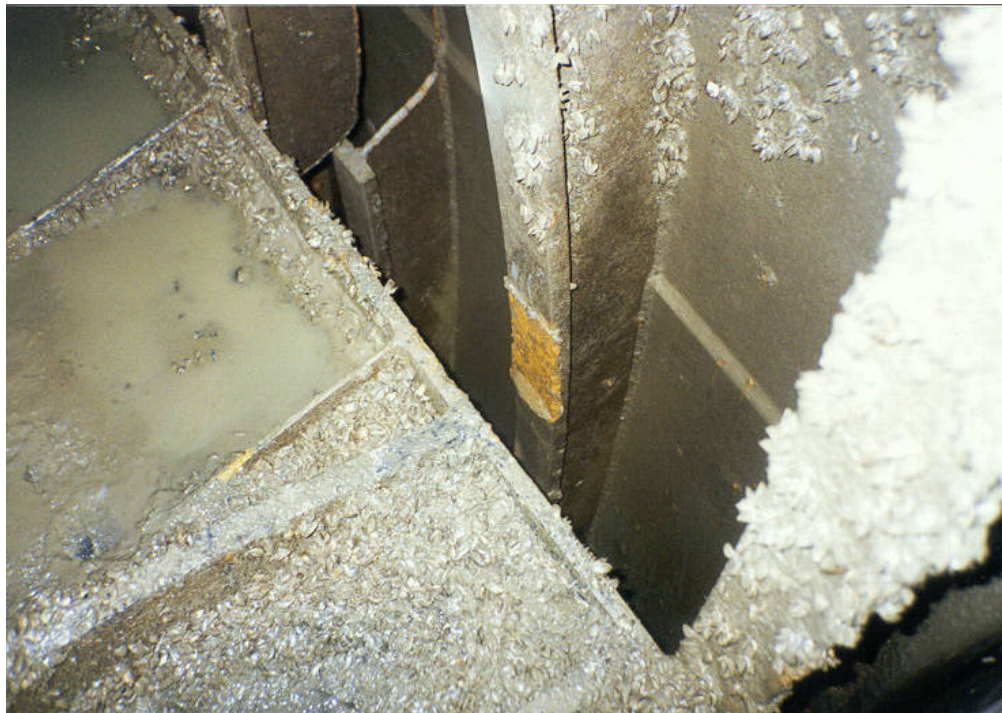
Figure 6.5.2.D. Failure of Weld at 2nd Vertical Rib

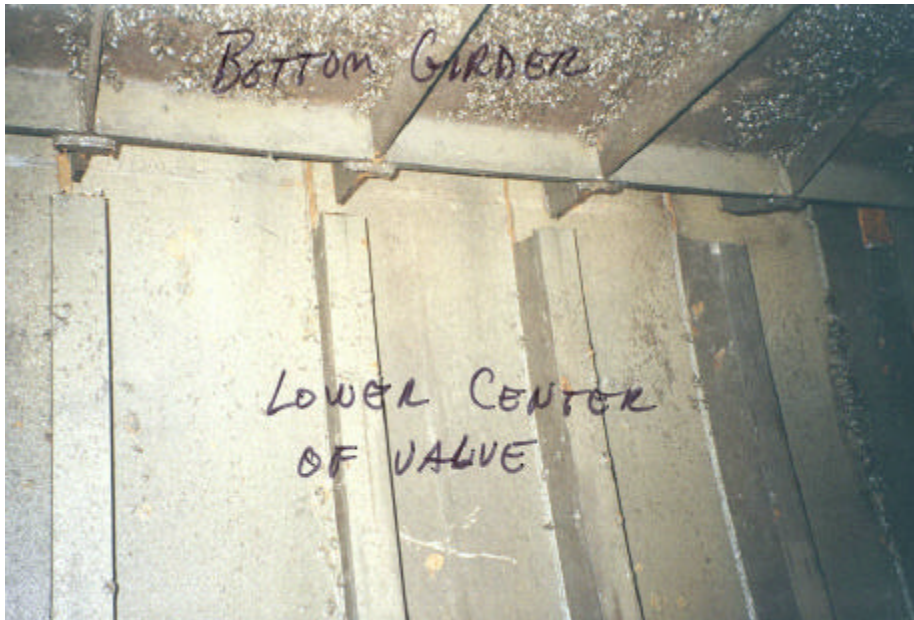
Figure 6.5.2.E. Shear Failure of Vertical Ribs in Middle of Valve
Note vertical rib on far right where initial weld failed.

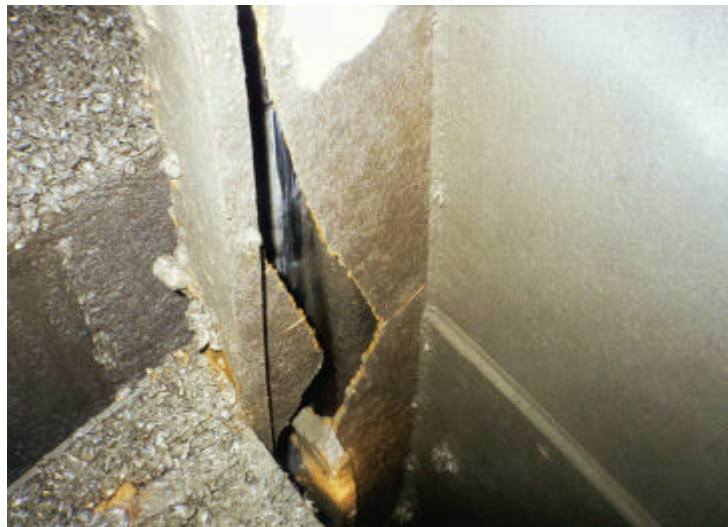
Figure 6.5.2.F. Shear Failure and End Vertical Rib
